**EFFECTS OF COMMERCIALY AVAILABLE PROTECTIVE
COATINGS ON STRESS-CORROSION PROPERTIES OF
SUPERSONIC-TRANSPORT SKIN MATERIALS**

FINAL SUMMARY REPORT

**NATIONAL AERONAUTICS AND SPACE ADMINISTRATION
For the period between 1 June, 1964, and 31 January, 1966**

**Southern Research Institute
Birmingham, Alabama 35205
22 March, 1966
7685-1417-XV**

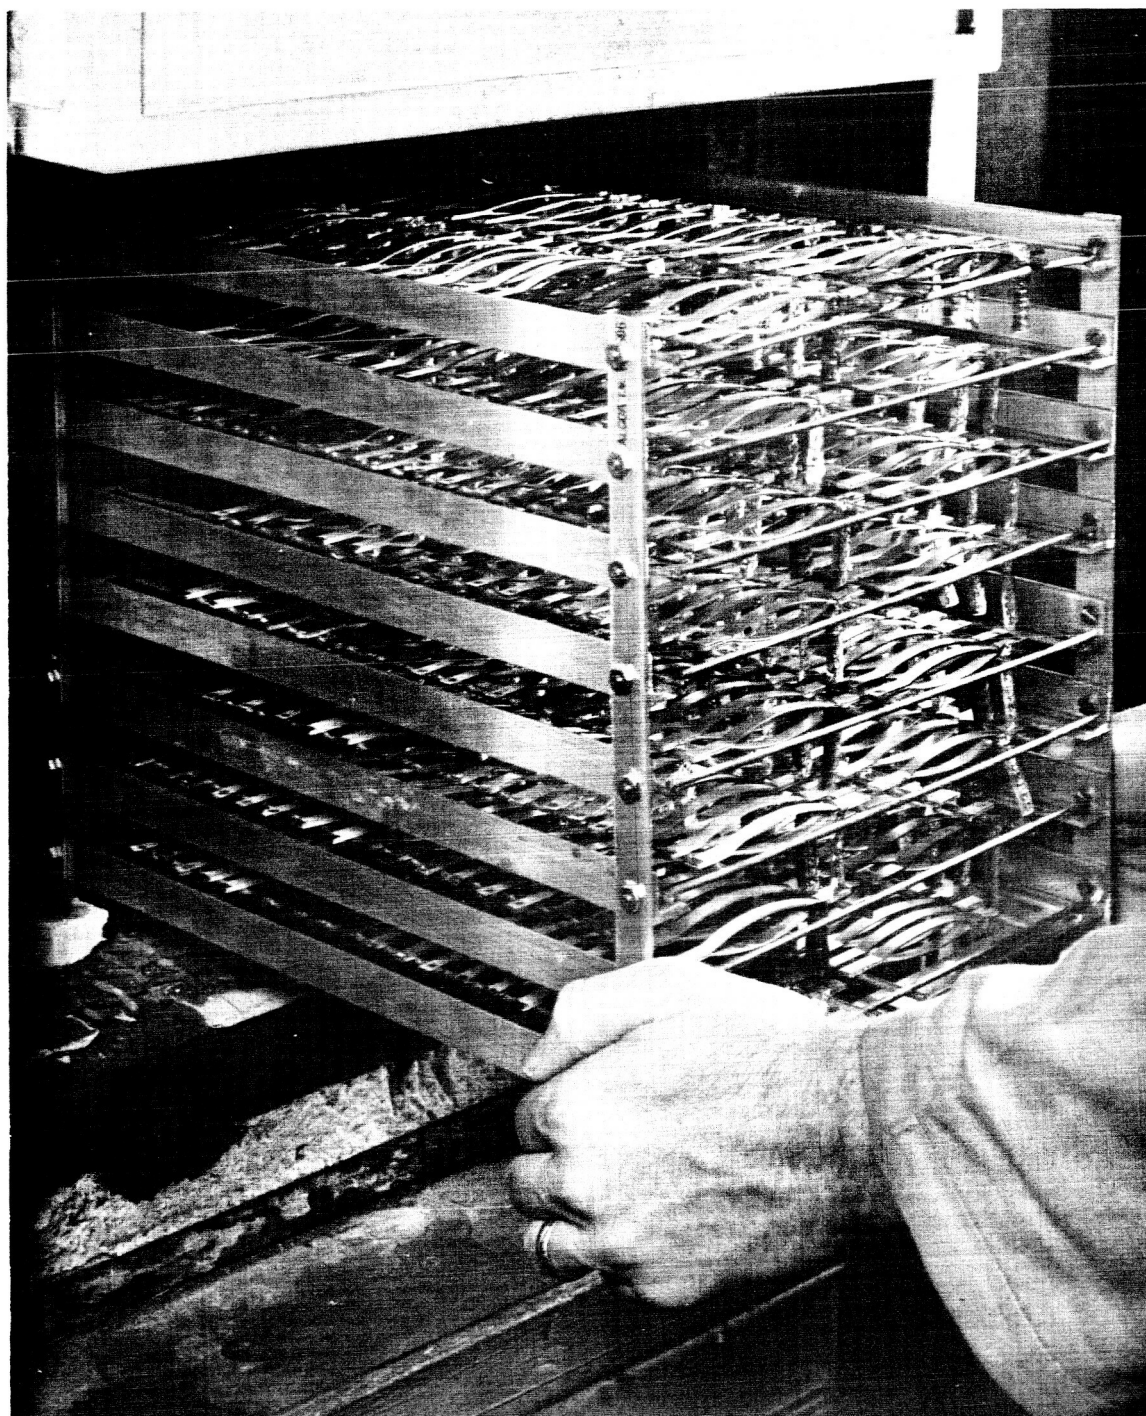
Figure 8. Metal rack and specimens being placed in the 550° F exposure oven.

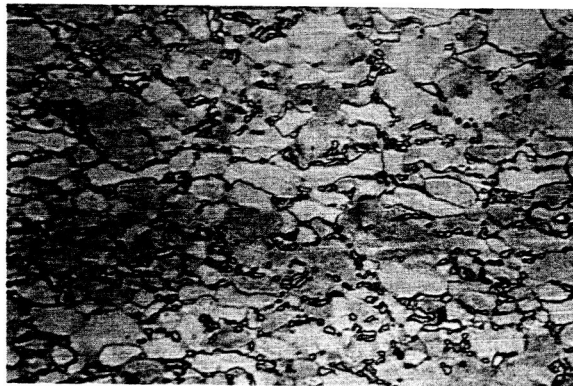
(a) Bright field.
100X

(b) Bright field.
500X

(c) Polarized light.
500X

The differences between the primary and secondary α , and the appearance of the β particles is more clearly seen in the 500X bright-field view in Figure 18 (b). This view shows that the β particles appear in the grain boundaries of either primary or secondary α but in the grain interiors of only the secondary α . These structural phenomena are emphasized under polarized illumination of the same field, as shown in Figure 18 (c). Under polarized illumination the primary α grains appear clear and black, the secondary α grains are a mottled dark gray, and the β particles have a bright crystalline appearance.

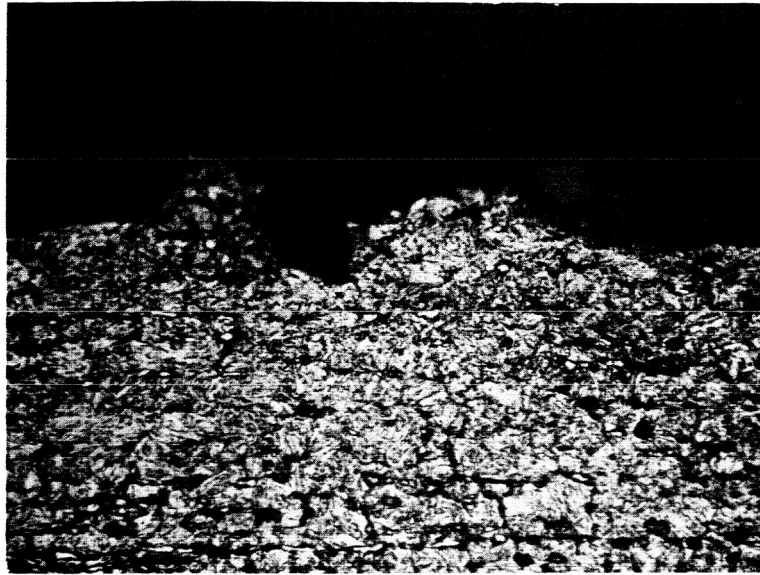
(a) Ductile specimen. 500X

Figure 27. Maximum surface roughness of AM 350 SCT substrate coated with Zinc in Silicate Vehicle (ZSV).
(a) Specimen A3U2L1A with good bend ductility.
(b) Specimen A3D2L1B with poor bend ductility.
Both specimens exposed to humid salt at 95° F for 1000 hr.

The only coated specimens of AM 350 that had reduced ductility were some that were coated with Zinc in Silicate Vehicle and exposed to humid salt. Metallographic examination revealed no corrosive attack from the salt but did show that the substrate surfaces of ductile and embrittled specimens had been considerably distorted, apparently in preparation for the coating. As shown in Figure 27, the maximum surface roughness was greater in the embrittled specimen than in the ductile specimen. The metallographic examination did not reveal, however, why the reduced ductilities were confined to specimens exposed to salt.

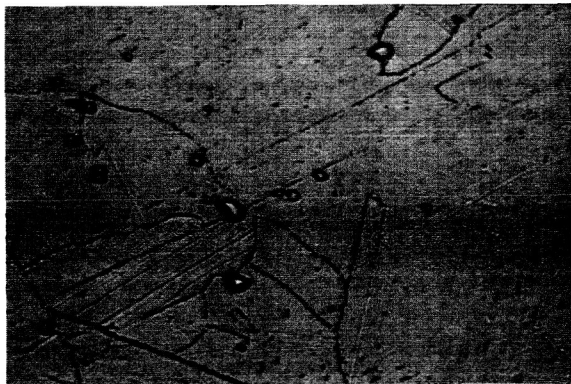
(a) General view.
100X

(b) Bright-field view of
old and new twins.
500X

(c) Polarized-light view
of old and new twins.
500X

Figure 28. Rene 41 original structure prior to exposure. Shows precipitated carbides in old grain and twin boundaries, and new grain and twin boundaries without precipitated carbides.

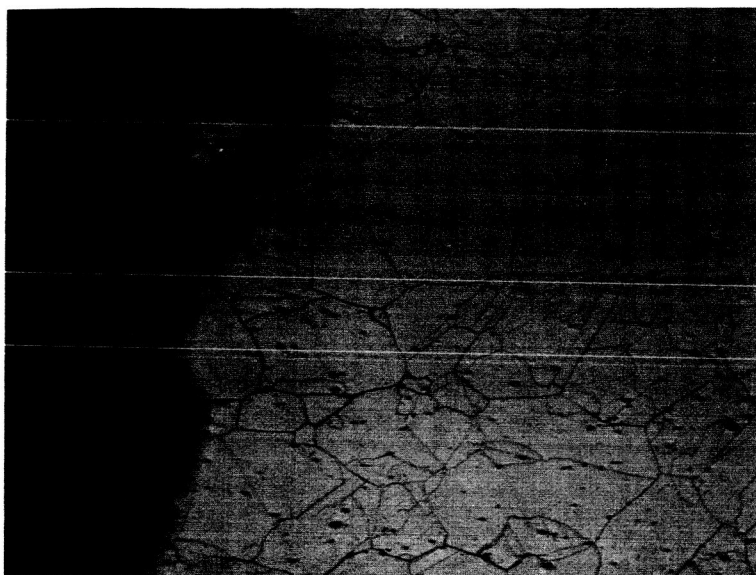
(a) With salt. 100X

(b) No salt. 100X

Figure 29 shows the structures at the fracture surfaces of two specimens exposed for 5000 hr at 550° F. The specimen in Figure 29 (a) was exposed with salt but produced no evidence of attack by the salt. The fracture in the unsalted specimen shown in Figure 29 (b) was quite similar to that of the salt-exposed specimen. Some surface cracks like those visible in Figure 29 (b) were present in the unsalted specimen but they were located only near the fracture and were probably opened up during the bend-ductility tests.
